**SUBJECT: CIM FLOAT ASSEMBLY WIRE TERMINATIONS**

**Number: 2018-18**  
**Product: CIM Series**  
**Date Issued: November 8, 2018**  
**From: Technical Service**

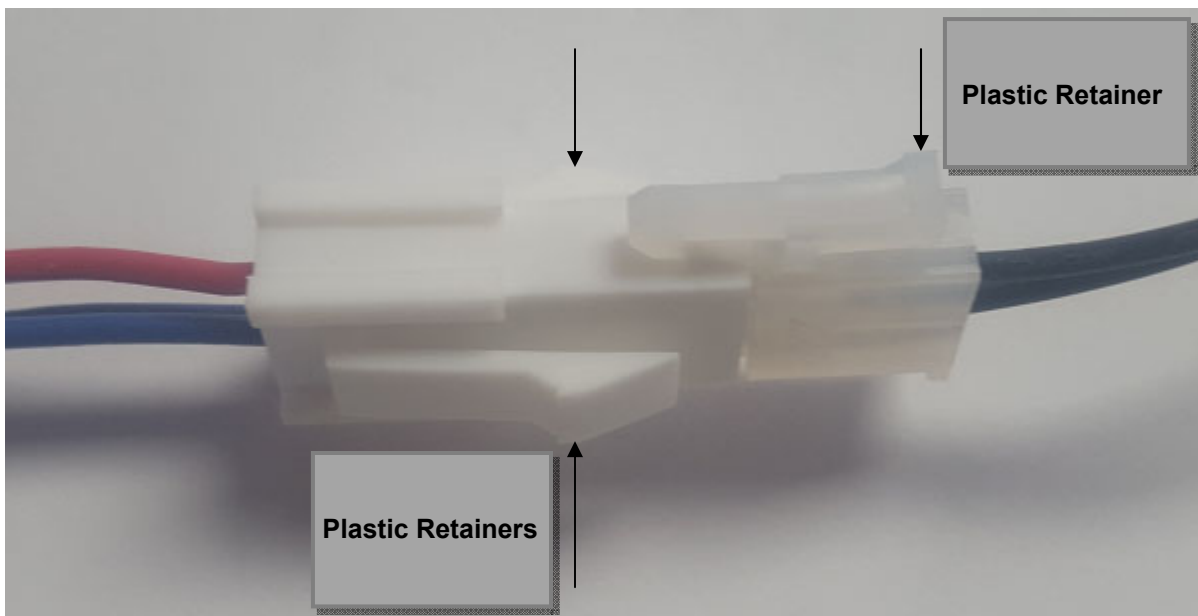
When disassembling the wiring harness connectors, **DO NOT** pull on the wires which the Molex wire termination pins are mounted inside the wire connectors.

**DO NOT** pull on the wires when separating the wire connections, the wire may be separated from the internal pin.

To separate the connectors, depress the two plastic retainers on the female portion of the connector while depressing the locking portion of the male connector; pull the two apart by separating the connectors, **DO NOT PULL** on the connector wires.
